CE-963

Lusby-Sheeler ^{Tenant} ~~House~~ House

C. 1860

INVENTORY FORM FOR STATE HISTORIC SITES SURVEY

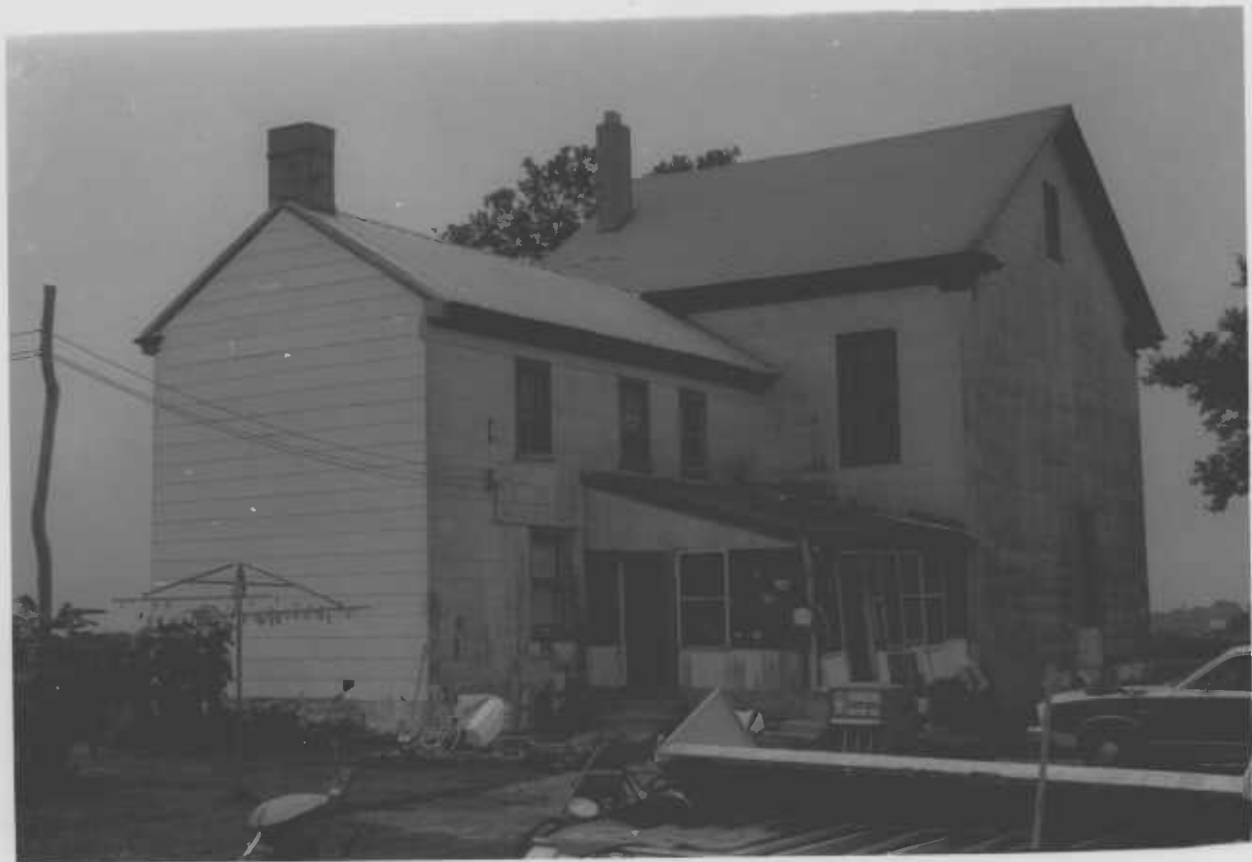
Lusby STEELE House
W EAST ELEVATION

The 2½ story frame has an asbestos sheathing over weatherboard and rests on a fieldstone foundation. The structure is capped with a medium sloped composition tile roof. A shed porch used to be attached to the main facade but has been ~~entirely~~ removed. The heavy timber framing with corner bracing with spaced studding has been left uncovered on the west side. A shed porch still remains on the north side of the kitchen wing.

The west (front) facade has a northern bay entrance with four light sidelights and panel below. The transom has been partially covered. Long 4/4 sash windows with plain trim occupy the two southern bays and three 4/4 windows are found on the second floor. Shutter pintels remain but the shutters themselves have disappeared. Each corner of the main block is decorated with a pilaster which has been covered over by asbestos. The pilasters visually support a heavy modillion cornice. The attic is illuminated by two 6/6 sash dormers with fluted pilasters and a molded pediment.
